Issue Resolution

Labor op: T6028 3.7 hrs

Resolves Issue: Transmission overheating on grades.

SUBMITTED BY: __ RSM Region 8

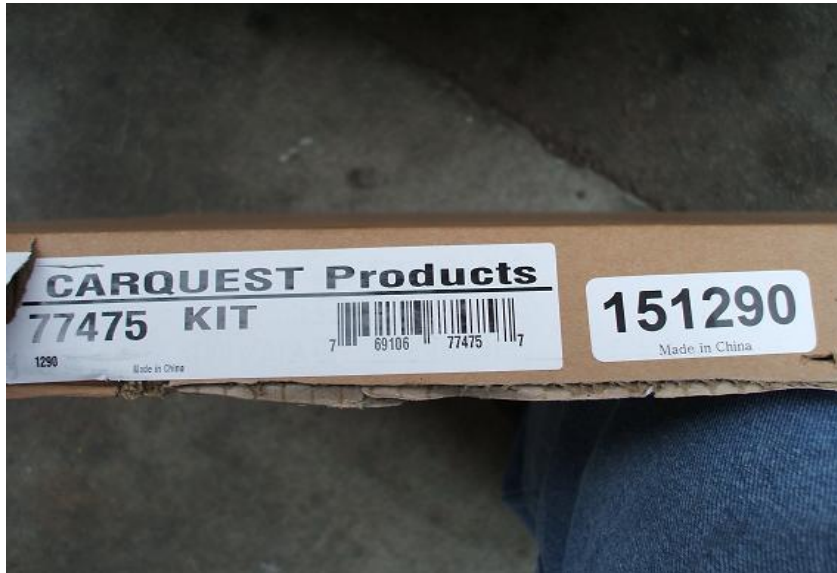
This is the cooler that was used. 151290 is a 9 row. Suggest using 151260, a 6 row. (less pressure drop)
